TELEVISION

August
1989

Vol. 39, No. 10
Issue 466

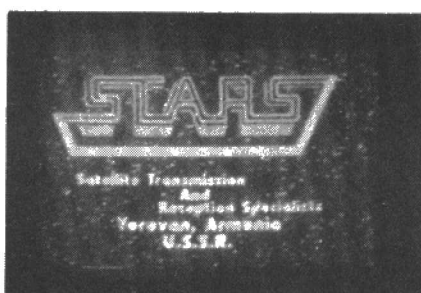
Left: The Iranian FUBK test pattern received via F2 layer propagation by Ryn Muntjewerff (Holland) this February, on ch. E2. Centre: Unusual C Band reception by Ian Waller from Intelsat at 21.5°W. Left: RTG Gabon test pattern received by Ian Waller via the Intelsat 1°W eastern hemispherical beam.

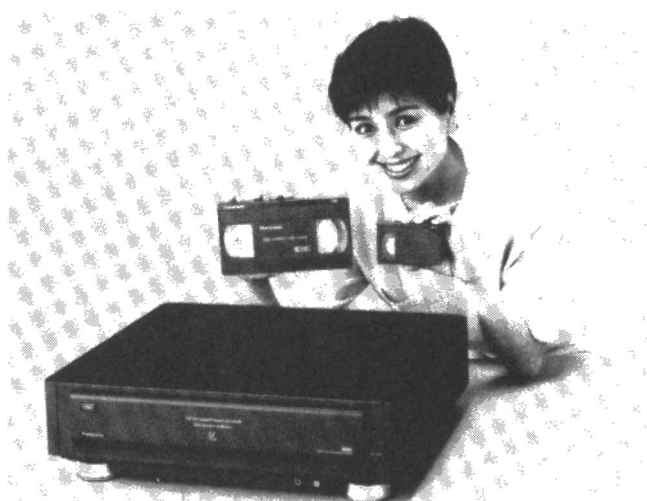
Panasonic's VHS/VHS-C compatible VCR.
